Service Bulletin

SB 1394T100-10RA-01

Autopilot Turn Coordinator

Loss of autopilot valid

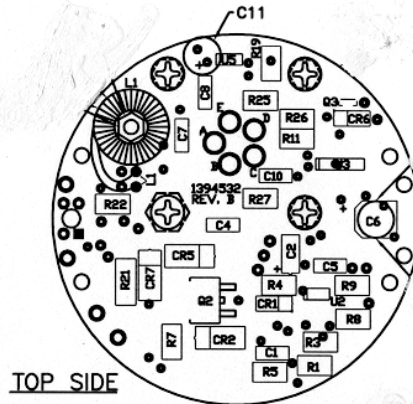
1. Intermittent power fluctuations may cause the loss of the autopilot valid signal from this unit. This service bulletin installs a 2 second delay before the autopilot output becomes invalid.
2. Under some conditions of high temperature operation the warning flag could intermittently drop in and out of view. This service bulletin changes the value of one resistor to improve the warning flag on/off operation performance window.
3. This service bulletin is optional based on individual owner request.

- A. Remove cover from unit.
- B. From the circuit board side opposite the connector locate the two via holes as shown. Install the 47uf capacitor with the positive lead to the centermost hole.
